Manhole Inspection Summary

Manhole # S37E__011MH

Location Address: **101 n gay st**

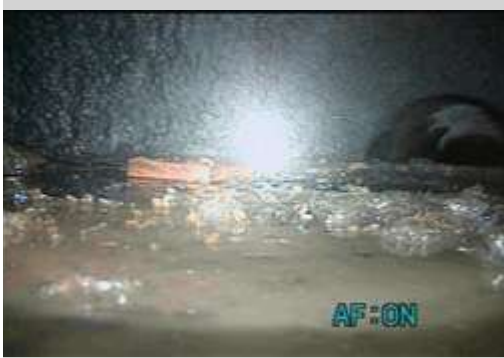
Defect 3

Condition: ☐ Sound ☐ Cracked ☐ Root Intrusion ☐ Deteriorated ☐ Leaks ☒ **Debris**

channel debris

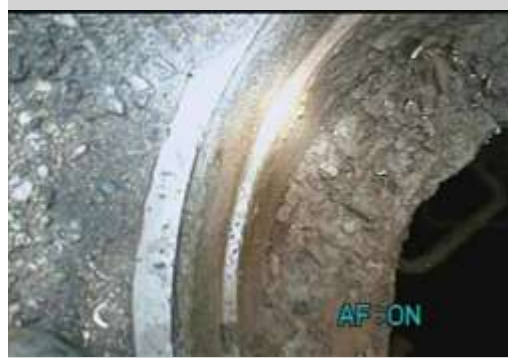
Defect 2

Offset: **4.5** (in.)

offset

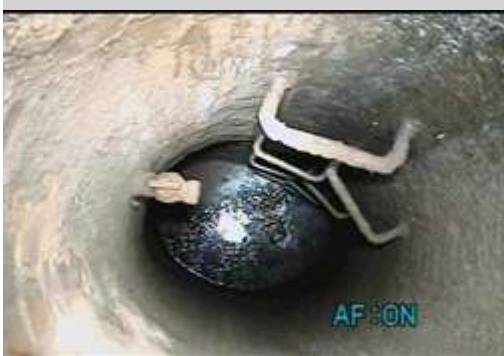
Defect 1

Infiltration: ☐ None ☐ Joint ☐ Cracks ☐ Mortar ☐ Roots ☒ **Wall**

Count: **8** Missing: **0** ☒ **Corroded**

Corroded steps, Wall Infiltration of Barrel and Corbel.

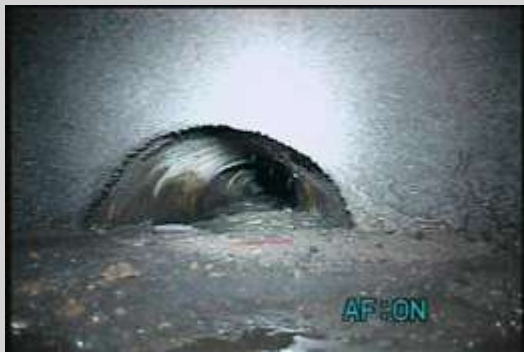
12 O'Clock Outflow

Deposits: ☐ None ☐ Mud ☐ Sludge ☒ **Debris** ☐ Grease

Silt Depth: 4 (in.) Deposits Extent: **Medium**
